## Alert scenarios for the Metropolitan Region of Recife-PE based on monitoring of rainfall and soil humidity – a case study

Case Study

Landslide early warning system  
Moisture monitoring  
Barreiras Formation  
Metropolitan Region of Recife

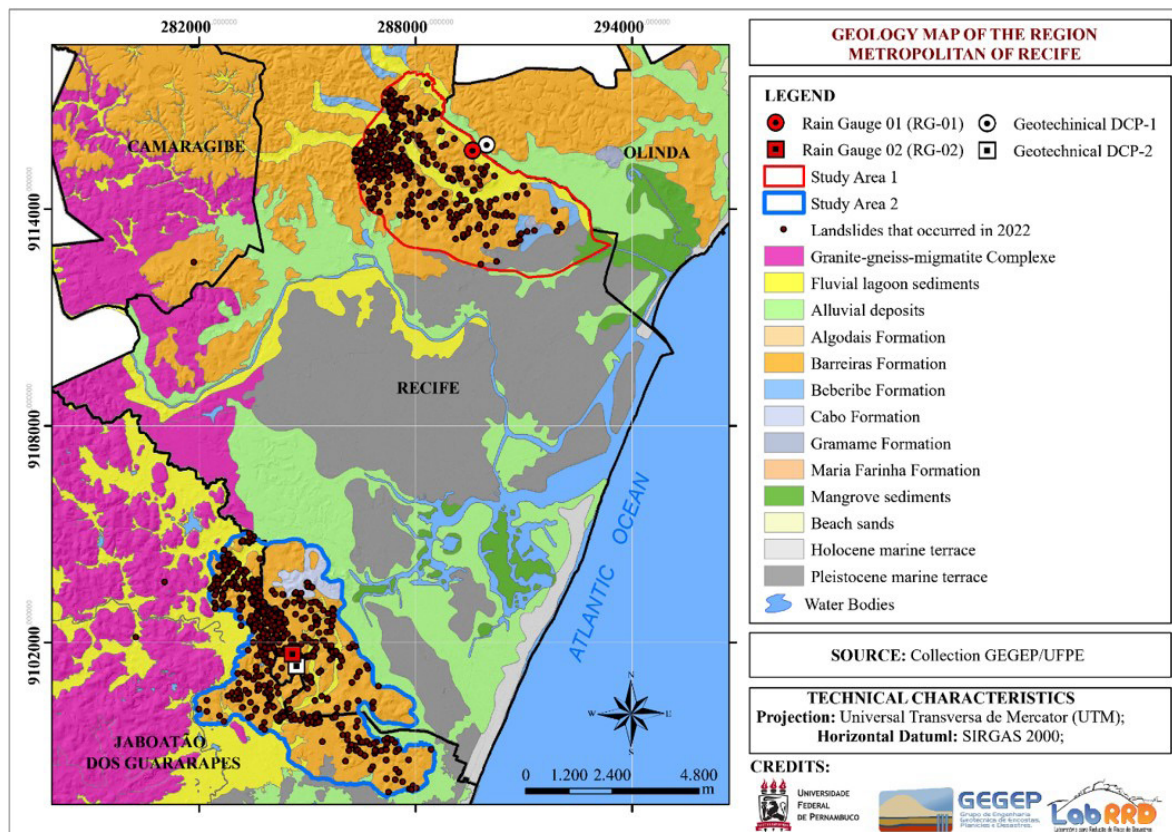
**Figure 1.** Location of the study areas, rain gauges, Geotechnical DCP, the spatial distribution of geological units in the MRR, and landslides that occurred in the study area in 2022.

When analyzing the map in Figure 1, it is observed that the MRR has a complex geology, with several different geological units. However, the two studied areas are mostly located on the Barreiras Formation. This geological unit has continental expression, of great occurrence on the Brazilian coast, being commonly found in the slope areas of the MRR (Bandeira & Coutinho, 2015; Coutinho et al., 2019).

Geotechnical DCP-1 and Geotechnical DCP-2 were selected, as shown in the map in Figure 1. Geotechnical DCP-1 is close to Area 1, while Geotechnical DCP-2 is

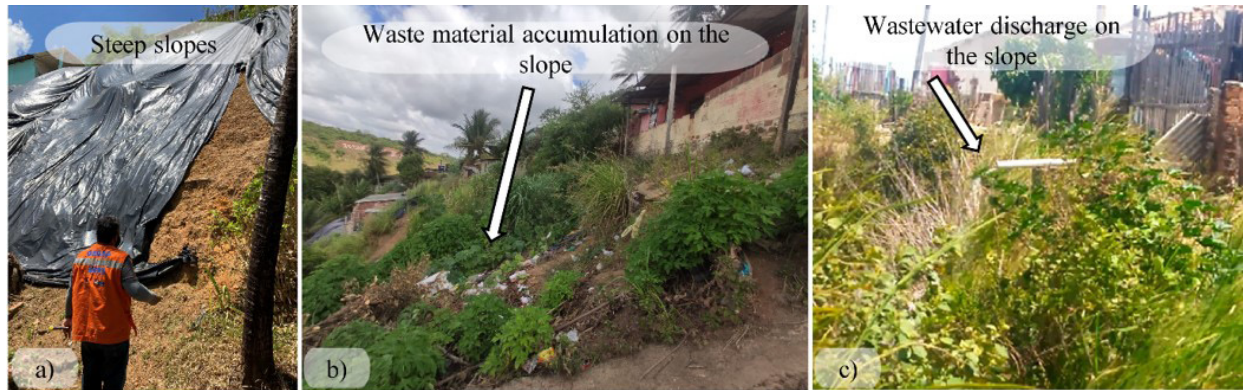
**Figure 2.** Scenarios identified in the study areas: a) steep slopes; b) waste material accumulation on the slopes; c) wastewater discharge on the slope.

landslides can be identified. Figure 2 illustrates the scenarios found in the study areas and shows the negative impact of anthropic intervention.

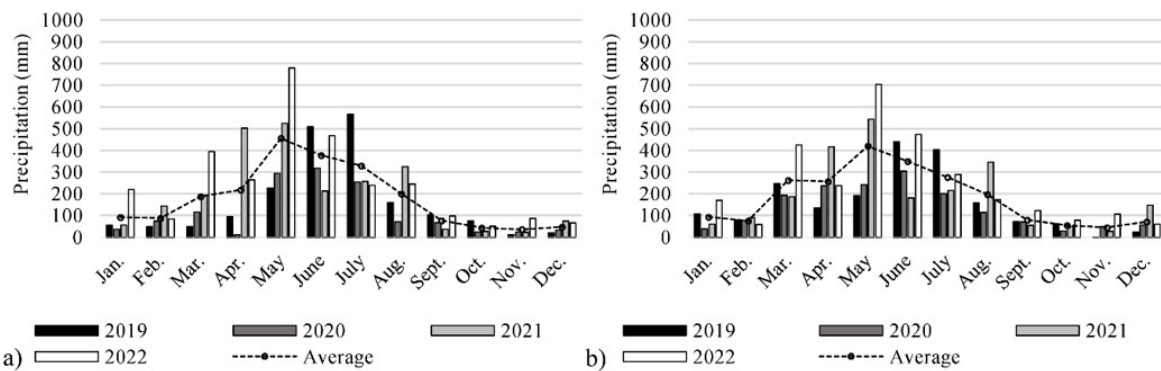
**Figure 3.** Precipitation recorded monthly between the years 2019 and 2022: a) RG-01 rain gauge; b) RG-02 rain gauge.

with monthly averages equal to or greater than 200 mm. In the analyzed period, May 2022 was the month with the highest monthly rainfall, 780 mm at RG-01 and 703 mm at RG-02.

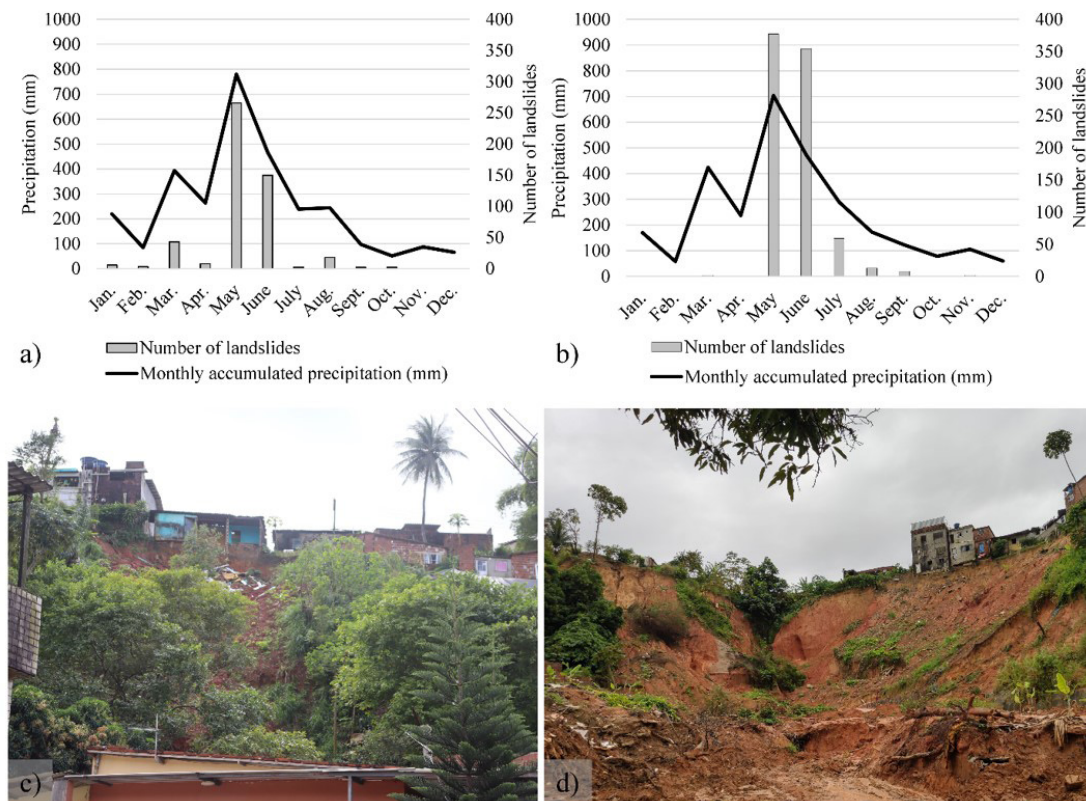
**Figure 4.** Landslides and monthly rainfall during 2022 in: a) Area 1; b) Area 2. Landslides that occurred on May 28, 2022: c) Córrego do Jenipapo – Area 1; d) Monte Verde – Area 2.

the slope (Gusmão Filho et al., 1997). Figure 4 shows two cases of landslides that occurred in the study areas on May 28, 2022. Figure 4c shows the planar landslide in Córrego do Jenipapo, located in Area 1, which caused fatalities and injuries. Figure 4d shows the landslide at Ave. Chapada do Araripe (Monte Verde), located in Area 2, on the border of Recife and Jaboatão dos Guararapes, which also resulted in fatalities.

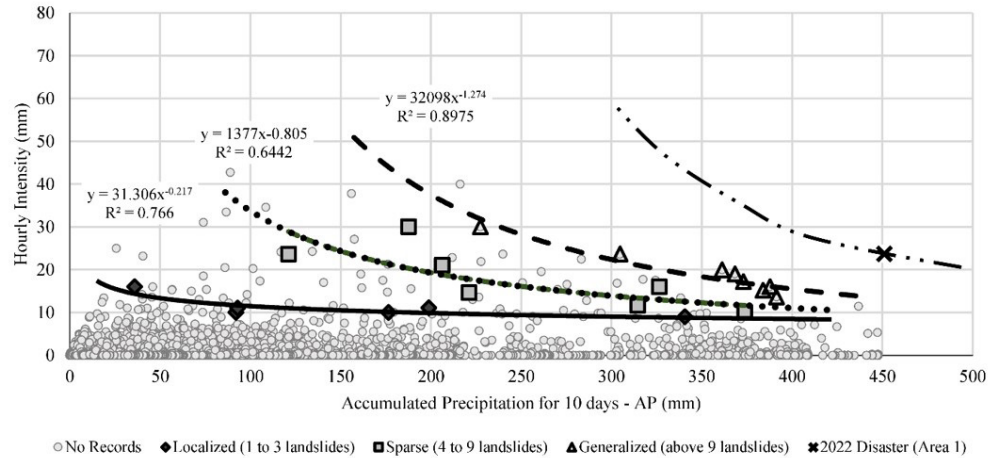
**Figure 5.** Correlation between hourly intensity by accumulated precipitation for 10 days [adapted from Coutinho & Delfino (2022)].

Figure 5 presents the proposal for critical rainfall thresholds developed by Coutinho & Delfino (2022) for Area 1. The events were divided into three groups: (i) localized (1 to 3 landslides); (ii) sparse (4 to 9 landslides); and (iii) generalized (above 9 landslides). It is observed in Figure 5 that the dot representing the accidents that occurred in 2022 in Area 1 is outside the trends established by those authors. This discrepancy highlights the need to consider extreme weather events caused by climate change in engineering design and to integrate risk and disaster management strategies.

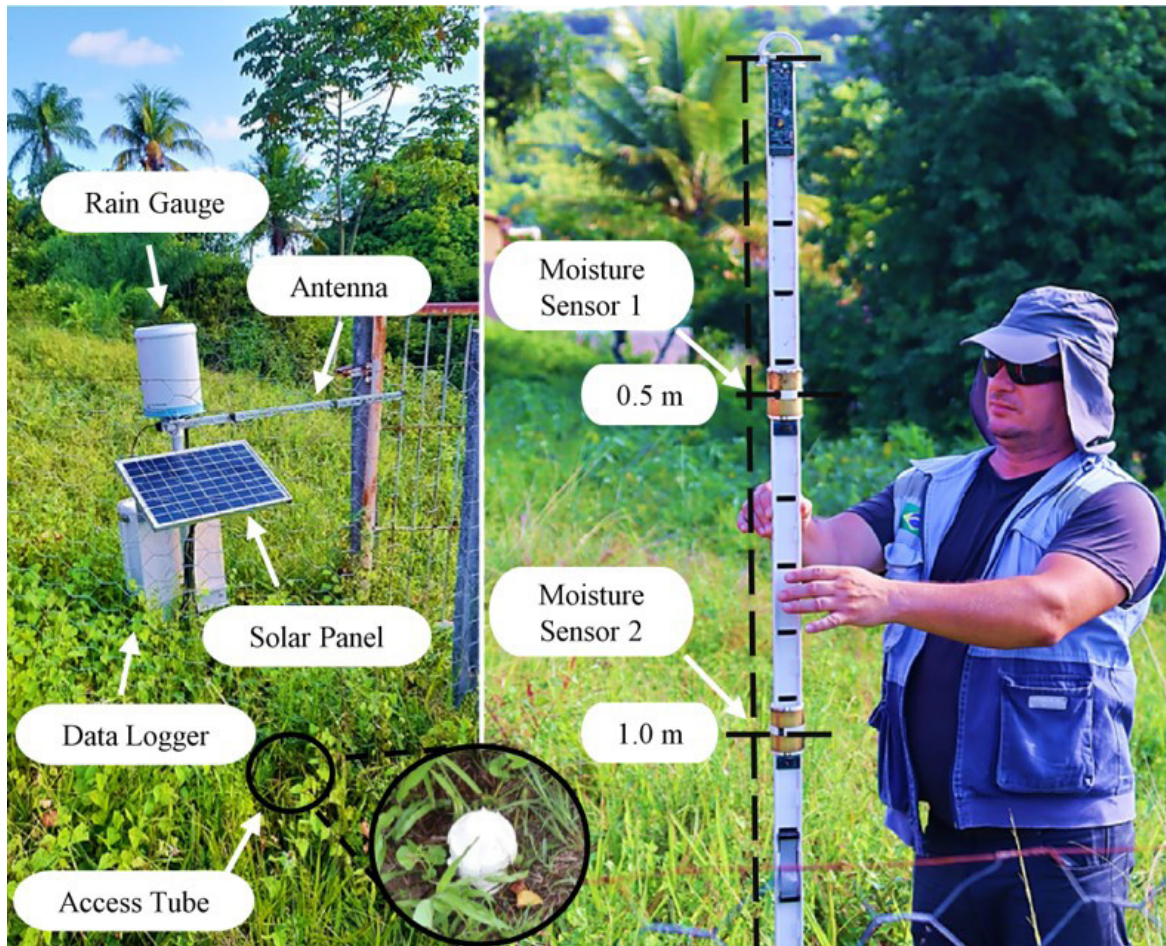
**Figure 6.** Composition of Geotechnical DCPs and arrangement of moisture sensors.

aim to improve the understanding of rainwater infiltration dynamics into the soil, adding environmental parameters to the system. Each Geotechnical DCP incorporates several devices, including a rain gauge to measure the amount of rainfall, capacitive moisture sensors to determine the in-situ volumetric water content of soil (%), a data logger for collecting and transmitting data, and a photovoltaic panel to provide energy to the system.

Through the collected data, the aim is to predict and identify the conditions in which the maximum moisture values are reached, which indicates soil saturation, the most unfavorable situation for the stability of slopes. At each Geotechnical DCP, moisture sensors were installed every 0.5 m deep, covering a range of 0.5 to 3.0 m. This resulted in a total of 6 moisture sensors per platform. Figure 6 illustrates the equipment that makes up a Geotechnical DCP and shows the arrangement of moisture sensors installed in an access tube implanted in the ground.

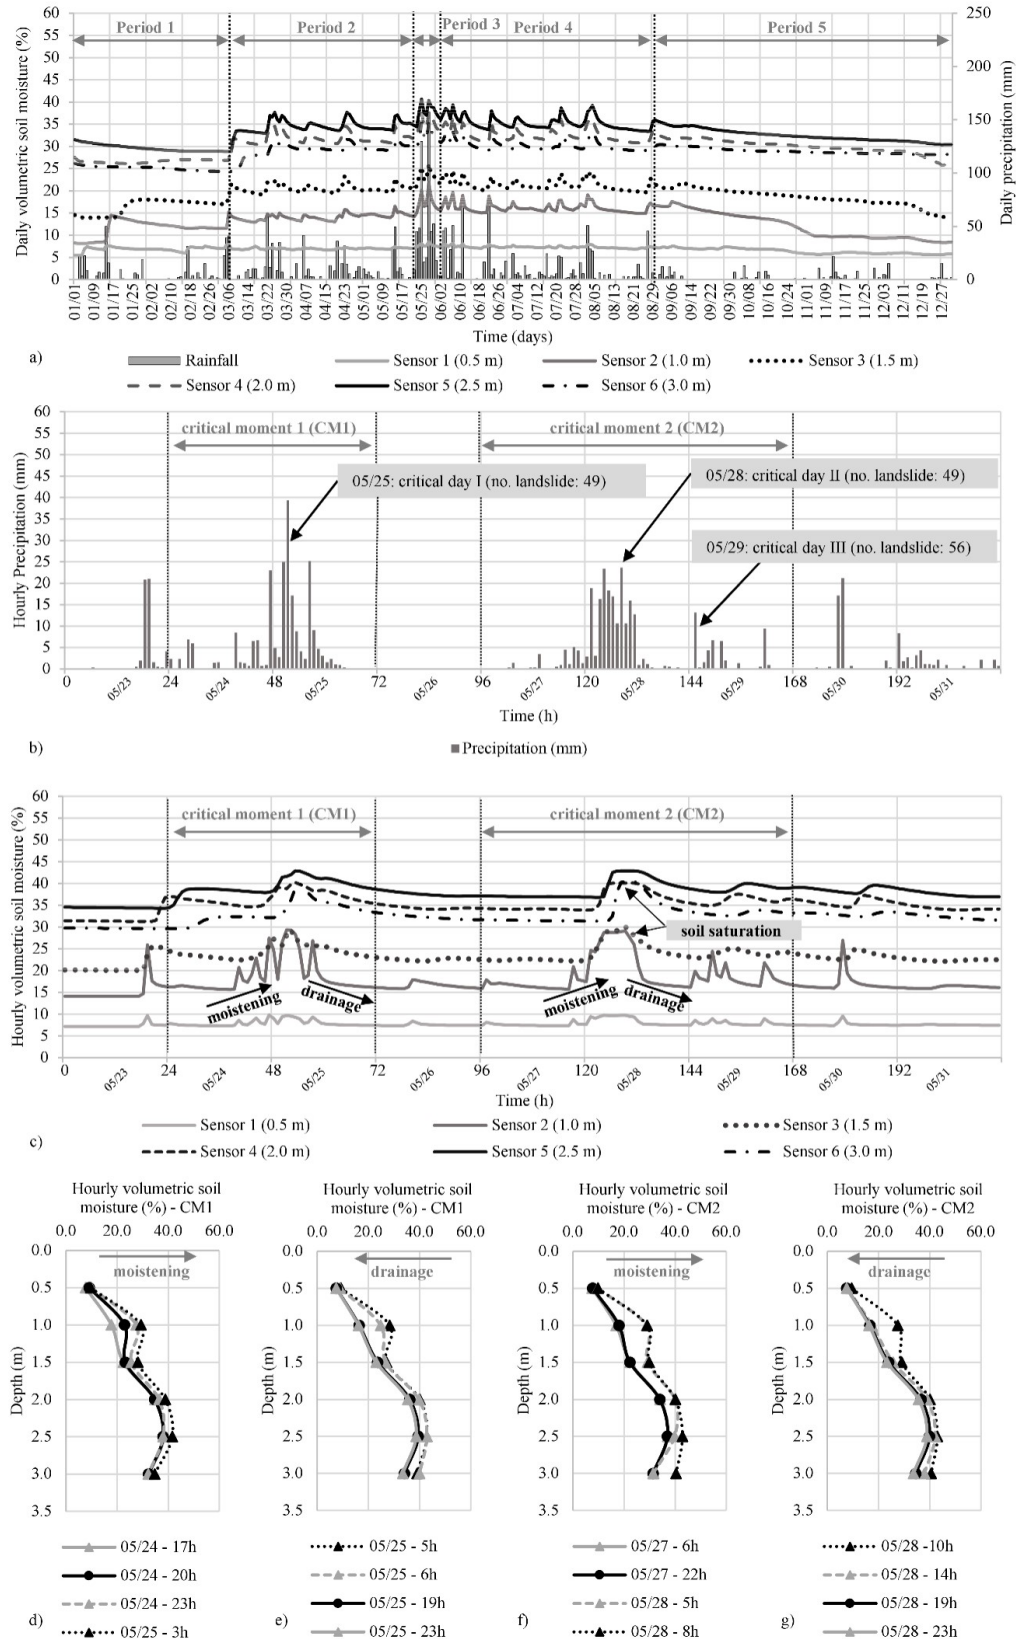
**Figure 7.** Monitoring data from Area 1: a) rainfall data and the average daily moisture between January 1 to December 31, 2022; b) period 3 hourly precipitation data; c) period 3 hourly average moisture data; d) wetting moisture profile – CM1; e) drainage moisture profile – CM1; f) wetting moisture profile – CM2; g) drainage moisture profile – CM2.

Figure 7a shows the graph of the average daily soil moisture measured by the Geotechnical DCP-1 and the daily precipitation recorded by the RG-01 during the year 2022. The data interval covers January 1 to December 31, 2022, and is divided into five smaller periods. The division criteria were the identification of relatively constant moisture values, to elucidate how the rainwater infiltration alters soil moisture. Table 2 presents the average volumetric soil moisture (%) and the corresponding standard deviation values for each period.

that in Period 2 there was an increase in the average moisture values at all monitored depths, compared to Period 1. In this period, it can be noticed that the humidity at all depths was more sensitive to rain as shown in Figure 7a.

The fifth period occurred between September 1 to December 31, 2022, lasting 122 days and illustrates the variation in humidity during the return of the driest period. During this period, the data in Table 2 shows that there was a reduction in average moisture compared to Period 4, mainly between 0.5-1.5 m. While in the deeper layers, the humidity decreases more slowly, as shown in Figure 7a.

The Period 3 recorded a large number of landslides. In Area 1, between May 25 and May 31, 262 landslides were registered, according to data provided by Recife's Civil Defense. Thus, for a better understanding of this period, more detailed analyses were carried out, considering precipitation and the average humidity on an hourly scale, as shown in Figures 7b and 7c.

Figure 7b shows two periods of intense precipitation: the first between May 24 and May 25, 2022, and the second between May 27 and May 29, 2022. These two periods were identified as Critical Moments (CM). In general, there is a rapid increase in humidity, followed by drainage due to the cessation of rainfalls. During times of greater precipitation, the formation of 'plateaus' is observed, indicated by arrows, which suggest a possible saturation of the soil.

registering 40 mm at 3 a.m. on May 25. Moisture profiles during wetting and draining in CM1 are shown in Figures 7d and 7e, respectively. These graphs show that rainwater infiltration occurs faster in surface layers between 0.5 and 1.5 m deep. The percentage change in moisture during wetting, in ascending order of depth, were: 27%, 65%, 25%, 12%, 9%, and 7%.

During Critical Moment 2 (CM2), 254 mm of rain accumulated in 48 h, with the peak hourly precipitation at 8 a.m. on 05/28, registering 24 mm. The CM2 moisture profiles are shown in Figures 7f and 7g. The graphs show a progressive increase in hourly humidity, mainly between 0.5 and 1.5 m depth. The percentage change in humidity during wetting, between 6 a.m. on May 27 and 8 a.m. on May 28, 2022, in ascending order of depth, were: 29%, 72%, 33%, 18%, 16%, and 28%.

The data from the Geotechnical DCP-1 and 2 showed consistent behavior in response to rainwater infiltration, with Figures 7 and 8, clearly showing changes in soil water content as a result of rainwater infiltration. The data showed that closer to surface, faster is the sensor response to rainwater infiltration and greater is the magnitude of volumetric water content increase. Similar results were described by Chávez et al. (2016), Crawford et al. (2019), and Bovolenta et al. (2020).

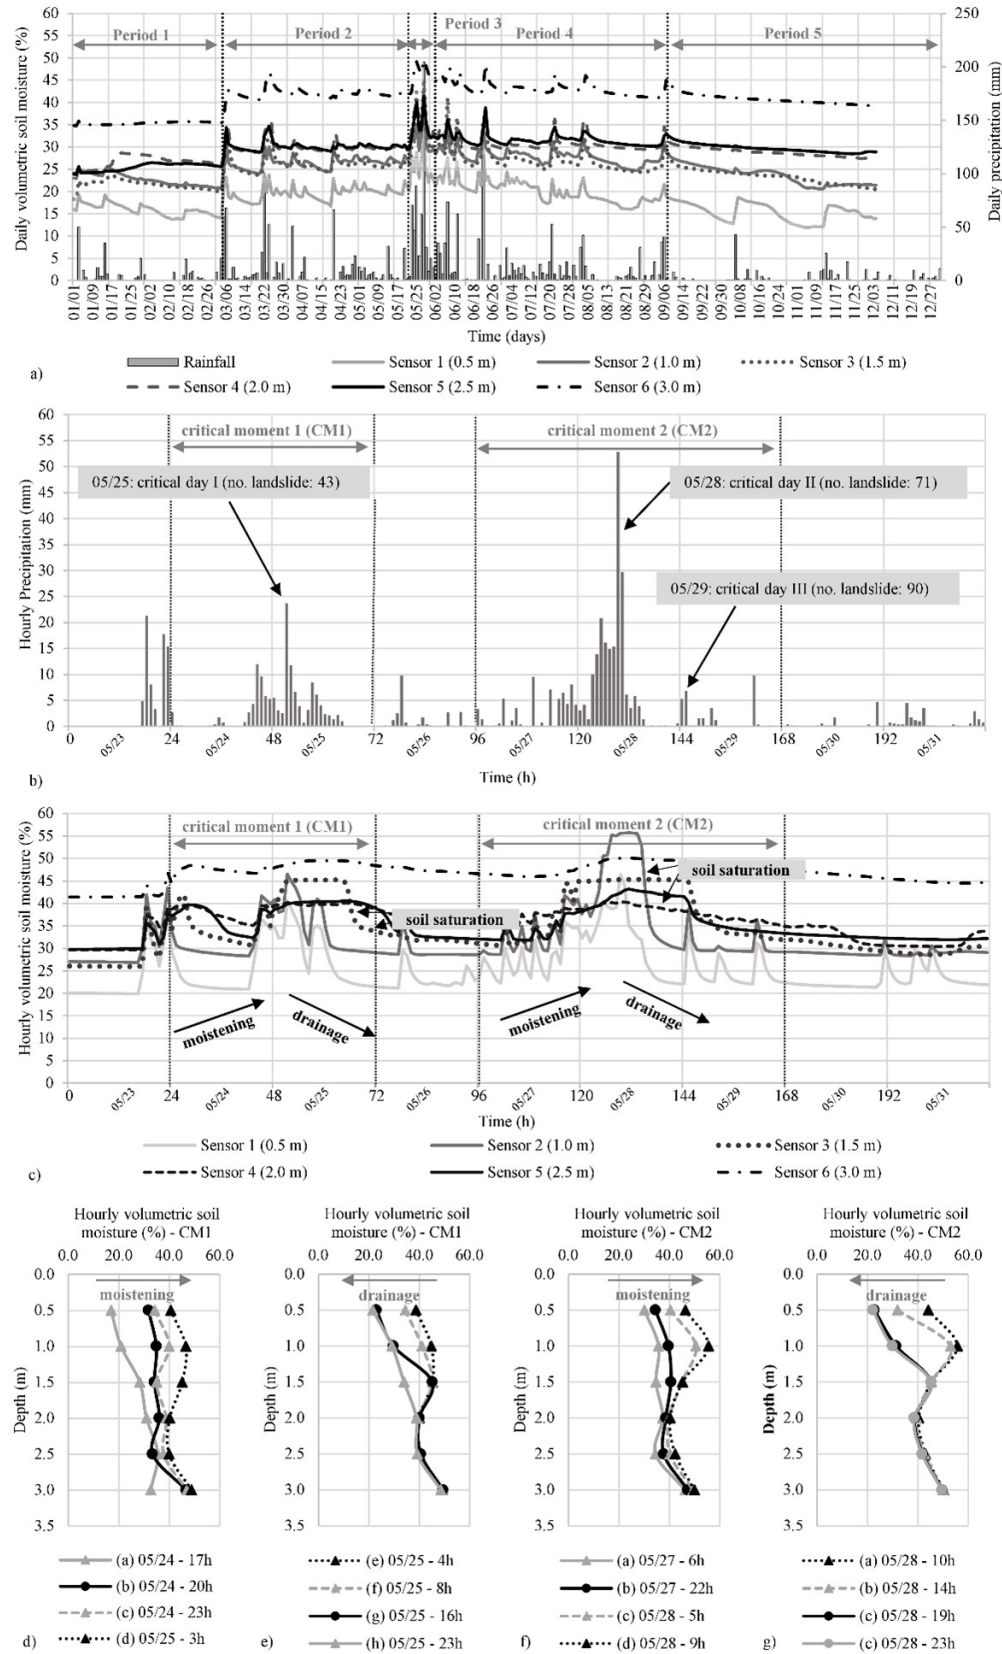
**Figure 8.** Monitoring data from Area 1: a) rainfall data and average daily moisture between January 01 and December 04, 2022; b) period 3 hourly precipitation data; c) period 3 hourly average moisture data; d) wetting moisture profile – CM1; e) drainage moisture profile – CM1; f) wetting moisture profile – CM2; g) drainage moisture profile – CM2.

Figure 8a shows the graph of the average daily soil moisture measured by the Geotechnical DCP-02 and the daily precipitation recorded at RG-02. The analysis interval starts on January 01 and ends on December 4, 2022, being divided into five smaller periods, using the same division criteria applied in Area 1. Table 3 presents the average volumetric soil moisture (%) and the corresponding standard deviation values for each period.

Due to the high volume of rainfall and rapid changes in humidity, Period 3 saw a large number of landslides. In Area 2, between May 25 and May 31, 336 landslides were registered, according to data provided by the Local Civil Defenses of Recife and Jaboatão dos Guararapes. Thus, analyses were also carried out considering precipitation and average moisture on an hourly scale, as shown in Figures 8b and 8c. Two Critical Moments (CM) were established: CM1 between May 24 and May 25, 2022, and CM2 between May 27 and May 29, 2022. At the two critical moments, the formation of 'plateaus' indicating soil saturation is highlighted in Figure 8c by arrows.

During the CM1, 90 mm of rain accumulated in 48 h, with the peak hourly precipitation at 3 a.m. on May 25, registering 23 mm. The CM1 moisture profiles are shown in Figures 8d and 8e. These graphs show a progressive increase in hourly humidity, mainly between 0.5 and 2.0 m depth, as the volume of rain increases. The percentage variation of increase in humidity, between 5 p.m. on May 24, 2022 and at 3 a.m. on May 25, 2022, in ascending order of depth were: 94%, 64%, 46%, 13%, 22%, 4%.

CM2 wetting and draining are shown in Figures 8f and 8g, respectively. These graphs show the increase in hourly humidity, mainly between 0.5 and 2.0 m depth, as the volume of rain increases. The increase in moisture between 6 a.m. on May 27 and 9 a.m. on May 28 was in ascending order of depth: 54%, 55%, 30%, 8%, 22%, and 8%.
